# **TLS–Based Documentation and Crack Detection of the Partially Collapsed Gwer Caravanserai, Kurdistan, Iraq**

**Bakhtyar Ahmed Mala \*<sup>1</sup>, Hoshang Jaafr Khidr <sup>1</sup>, Sapan Jabbar Faqe Ahmed <sup>1</sup>**

<sup>1</sup> Department of Gematics Engineering, College of Engineering, University of Salahaddin, Erbil 44001, Kurdistan Reign, Iraq.

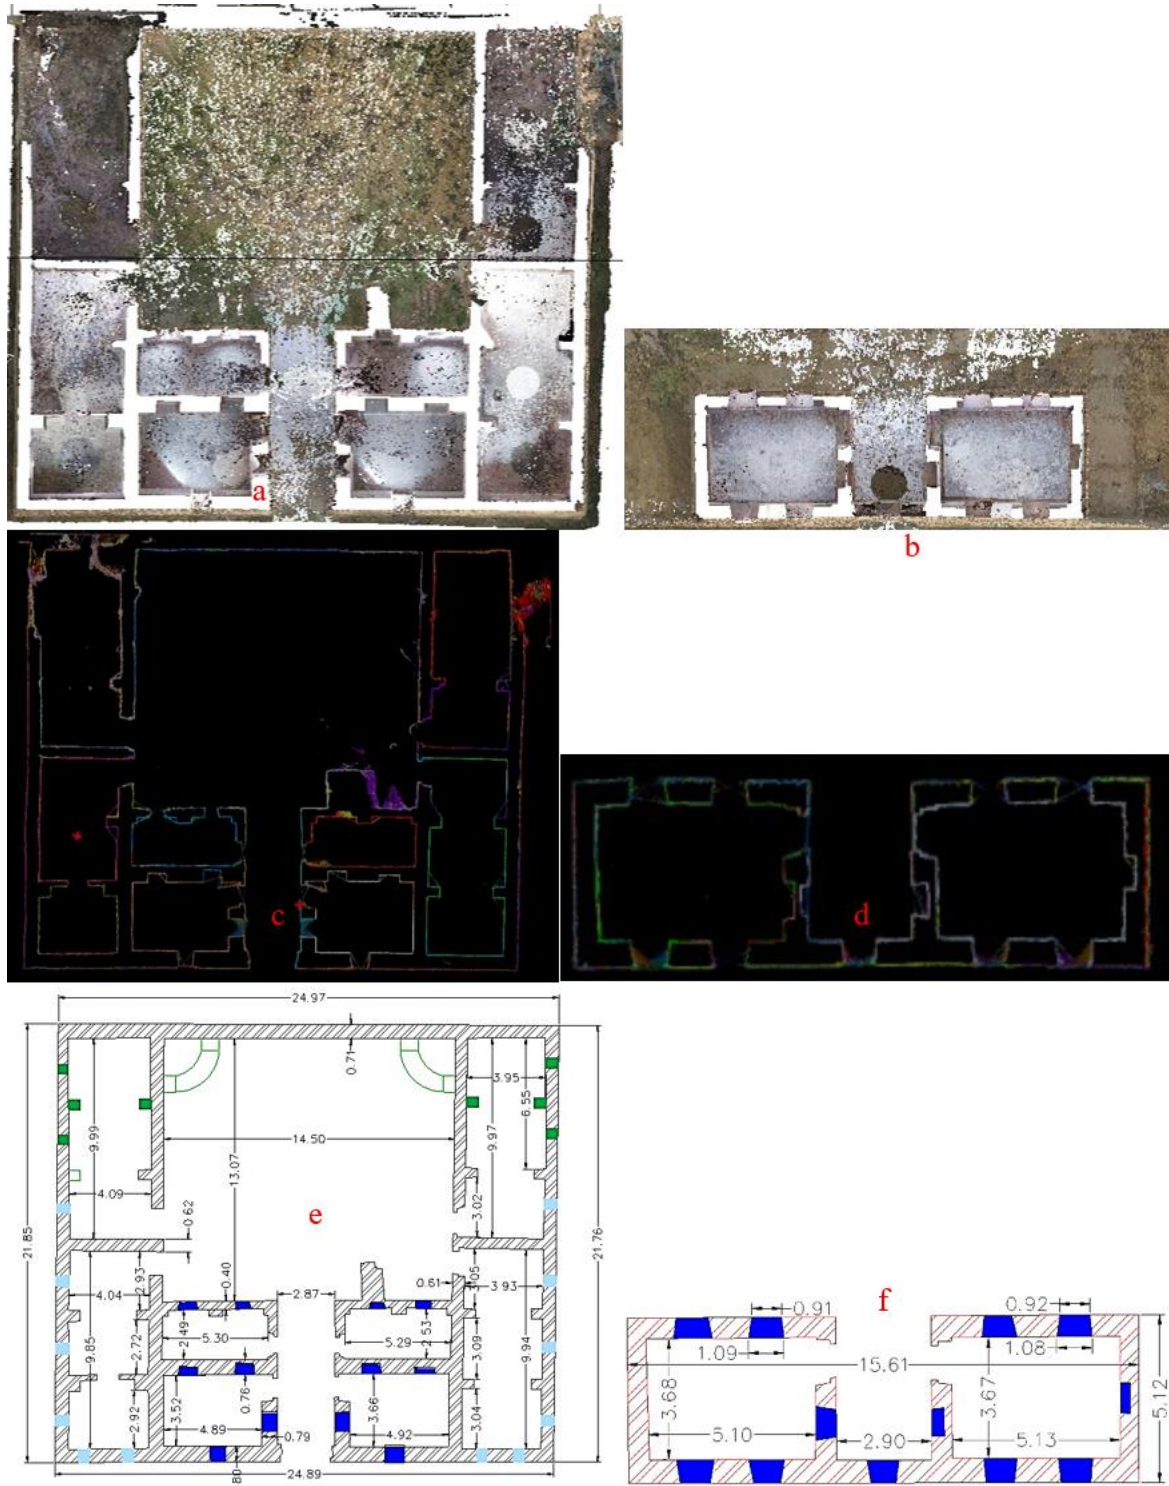
**Figure 5:** Reconstruction of the 2D plan of the Khan: a,b) First and second floor section plan of the data; c,d) First and second floor slice section point clouds from top view; e,f) Redrawing and reconstruction of the collapsed and non-collapsed parts of the 2D.

In the redrawing plan of the khan, shown in figure-5 (e, f), the green part illustrated the collapsed part, and the ceiling contains big cracks in both floors.

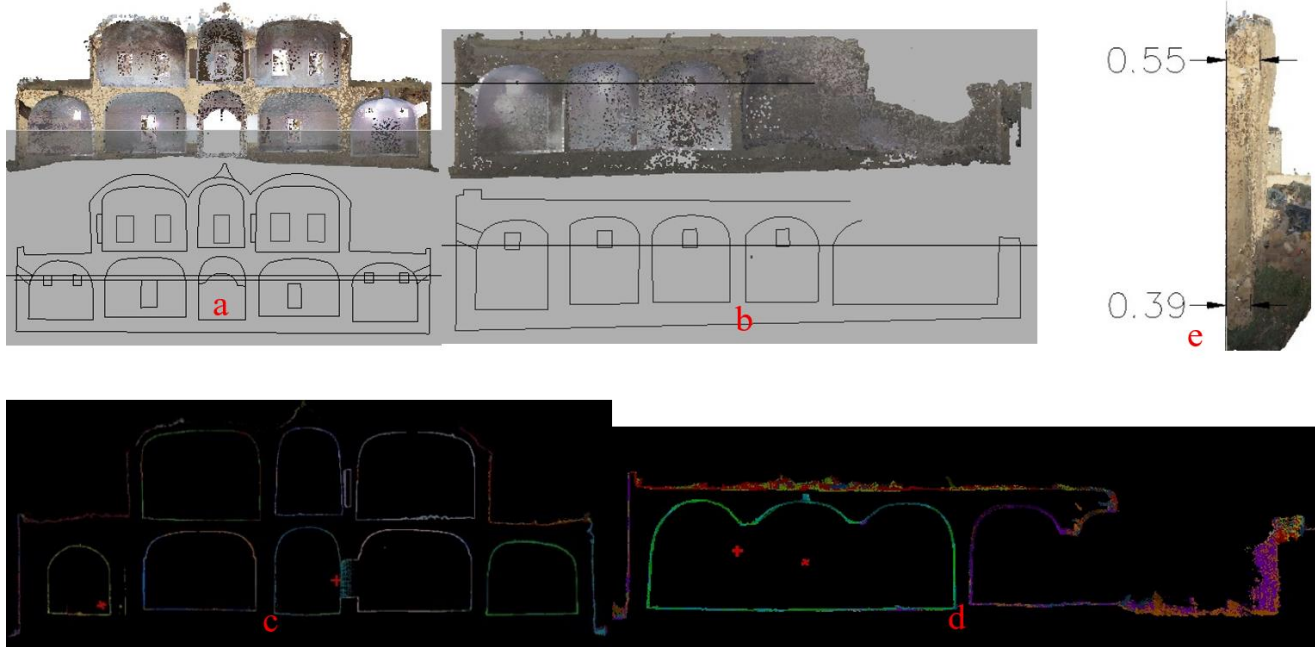
**Figure 6:** Front and right reconstruction sections of the Khan: a,c) Front sections in planimetric view and redrawing map; b,d) Right section in planimetric section and redrawing map; and e) Represents the amount of inclination of the selected wall.

The 16 cm value corresponds to the difference between the distances measured from the reference section to the wall at its base and at its top along the same vertical alignment. The 2D coordinates of the reference section were first determined. Subsequently, the coordinates of two points located on the same vertical line, one at the bottom and one at the top of the wall were recorded. Using the Pythagorean theorem, the distances from the reference section to each of these two points were calculated. The difference between these distances represents the horizontal deflection of the wall from the base to the top. This is a method of American Petroleum Institute (API) standard to compute the deflection of the vertical objects.

Figure 6 (a, c) shows the front of the building in terms of height, width, and shape, while Figure 6 (b, d) shows the right side of the building in terms of the design of the building and also shows the collapsed back part. On the other hand, attempts have been made to know the rate of deflection of its walls. One of the walls has been taken as a sample for this purpose. According to the results, despite the weakening of the walls due to cracks, which is the main reason for the accelerated collapse of the walls. As shown in “Figure 6 – e” the deflection rate reaches 16 cm.

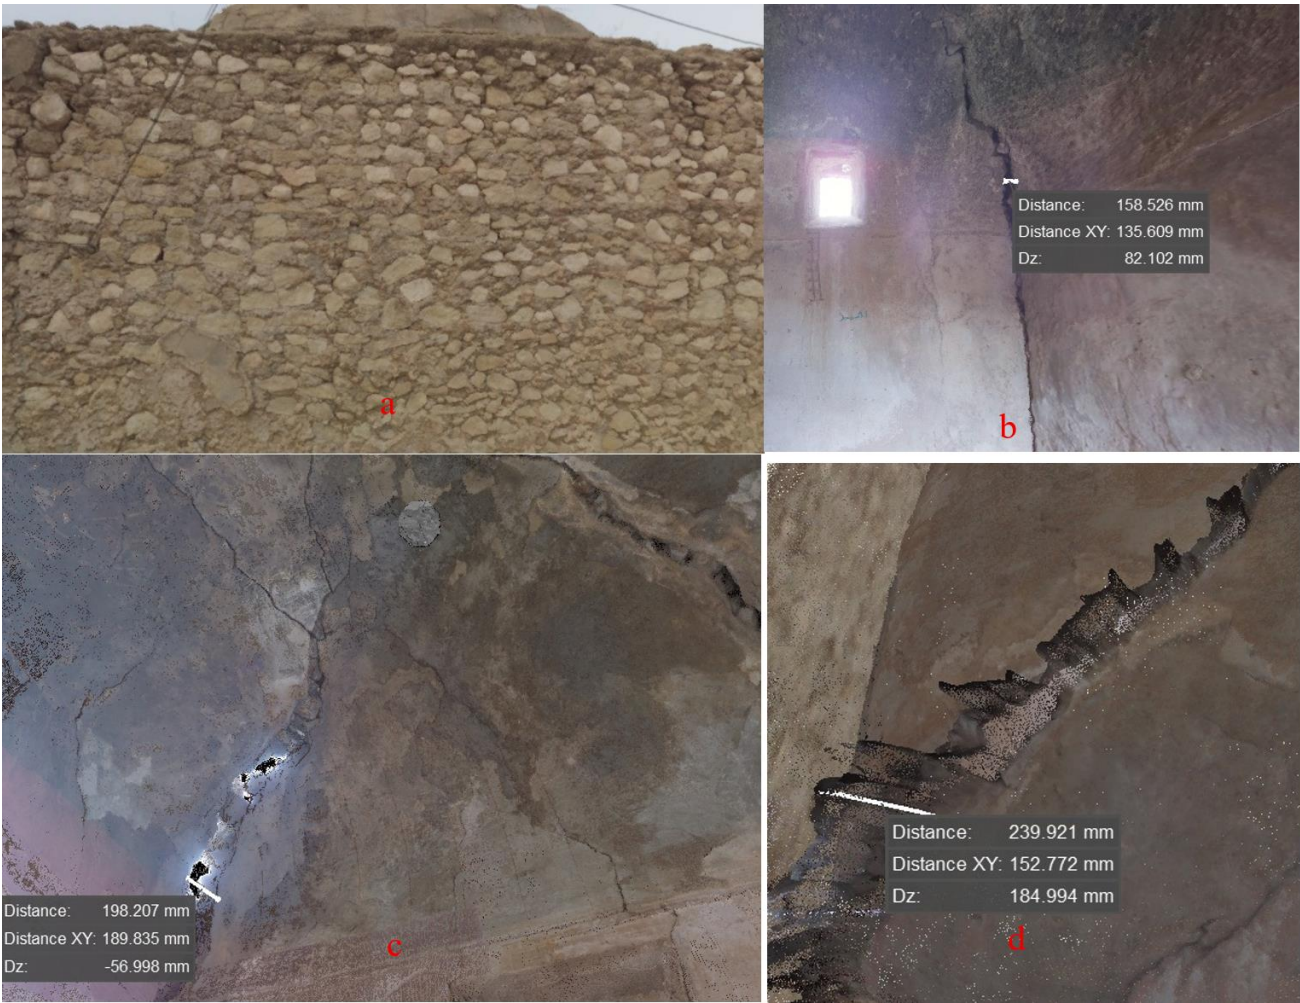
obtained and the measurements taken for the cracks. Unfortunately, it can be said that the survival of the building is very close to destruction due to the large number and size of cracks that can be clearly seen on both floors. The cracks have grown to the point that the roof has completely hollowed out, posing a serious risk of collapse. Because in addition to weakening the structure of the building due to these cracks, it allows water to enter all parts of the building during rainfall, which makes the demolition easier and faster. Figure 7 shows that the width of the cracks is about 20 cm, and the depth of the cracks exceeds the walls and ceilings in some places and is about 25 cm for unpenetrated walls and ceilings.

The crack detection process was based on a comprehensive visual inspection and direct measurement of crack width and depth across all structural elements, including walls and slabs on both floors. The investigation revealed a huge number of cracks distributed throughout the building. These cracks were primarily classified into two main categories based on their depth and structural impact: penetrated cracks, which extend through the full thickness of walls and slabs, and unpenetrated cracks, which are limited to surface or partial depth. Several penetrated cracks were identified in both the walls and slabs, particularly on the

second floor, where some cracks fully passed through the structural elements, indicating severe structural deterioration. Furthermore, the cracks were categorized according to their orientation. The observed crack patterns include vertical, horizontal, diagonal, and random orientations, and they are

present in both walls and slabs. The distribution of cracks in all directions suggests that the damage is not localized but affects the overall structural system. Table 1 summarizes the crack classification based on orientation, penetration condition, and location.

Figure 7: Crack detection and measurements on the non-collapsed part: a) Outside cracks on the wall, b) a crack in the first floor, c) cracks in the second-floor ceiling that have completely made a hole in the ceiling, and d) the depth of the crack on the second.

Based on these observations, this study strongly recommends urgent intervention by relevant stakeholders. If the long-term preservation of the historical heritage of the Khan of Gwer is a priority, immediate structural stabilization and rehabilitation measures are essential. Without prompt conservation efforts, the building faces a high risk of progressive deterioration and potential total collapse.

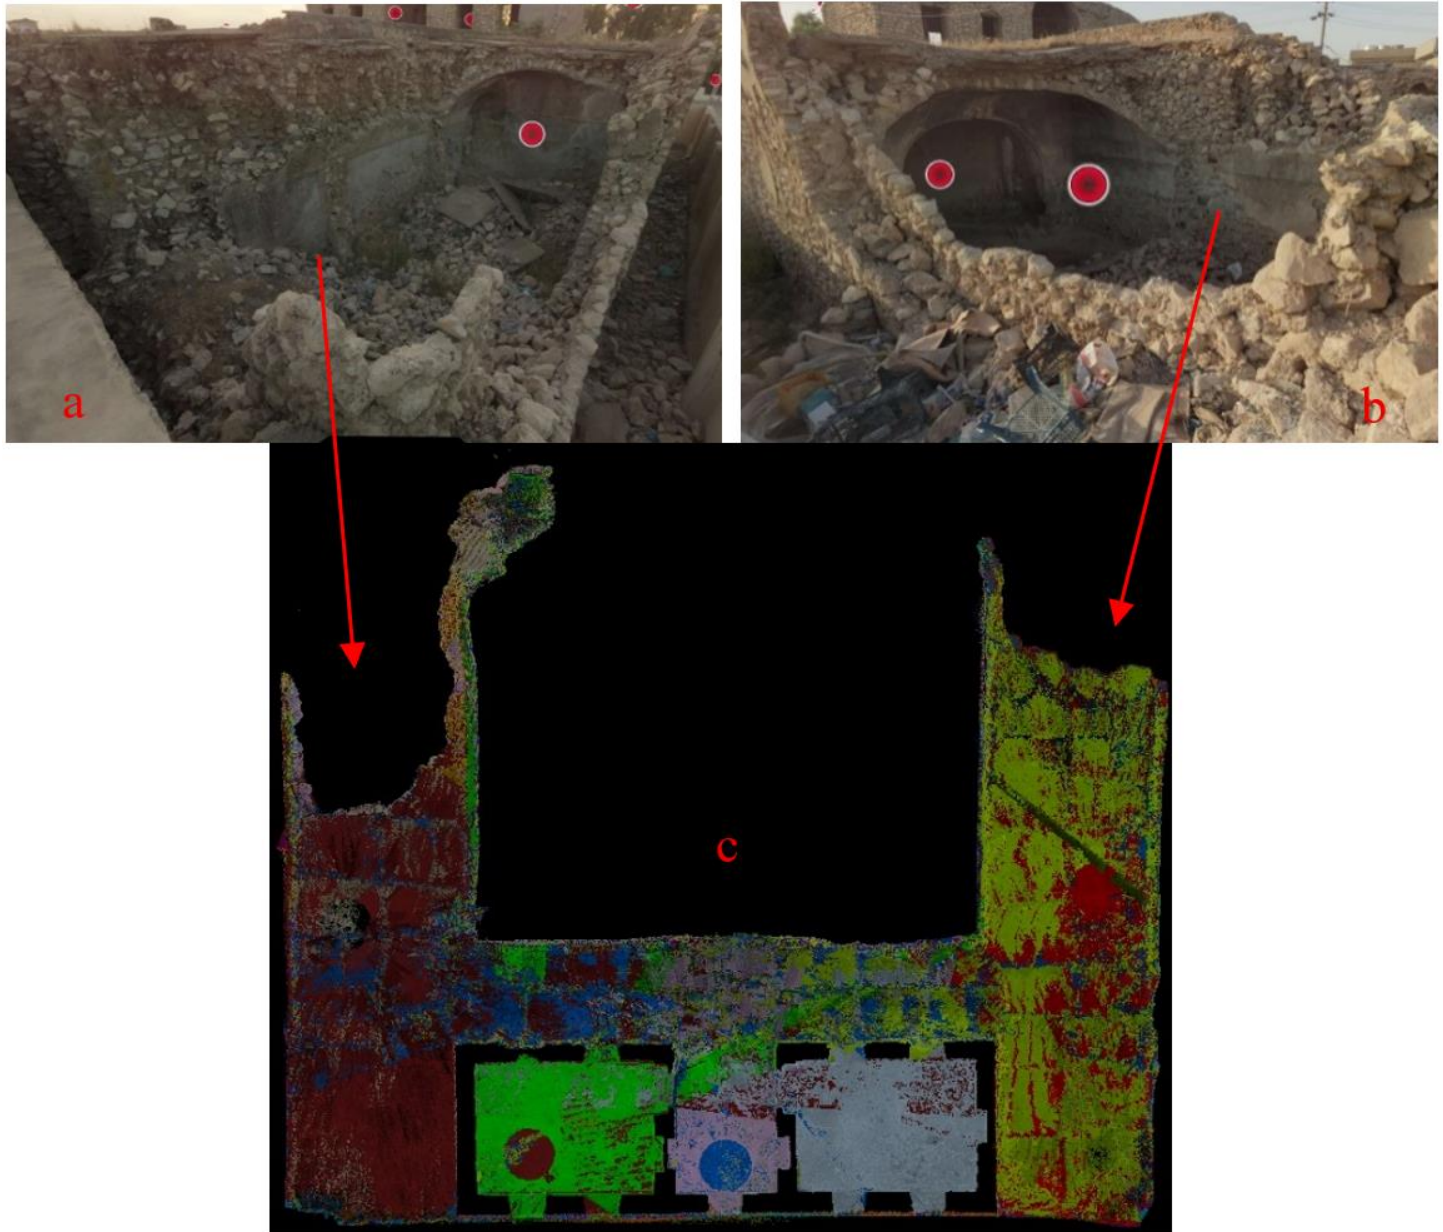
Unfortunately, a prominent part of the building has completely collapsed, located at the back of the building. As can be seen in **Error! Reference source not found.** approximately 50% of the roof on the right side is estimated to have collapsed, and the left

side is roughly 20% collapsed. Despite the presence of many cracks in the non-collapsed part of the roof, a large amount of weeds has grown on the roof, which causes the roof to crack and damage the structure of the building due to the growth of plant roots in the roof.

**Figure 8:** Collapsed part of the Gwer Caravanserai: a) Back right side collapsed ceiling, b) Back left side collapsed ceiling, and c) Top view ceiling section to show the collapsed part.

It can be concluded that the left-back side of the first floor collapsed by approximately 50%, while the right-back side of the same floor collapsed by about 20%.
