Investigation of the UAV Capability for Measuring Building's Cracks Dimensions

ABSTRACT

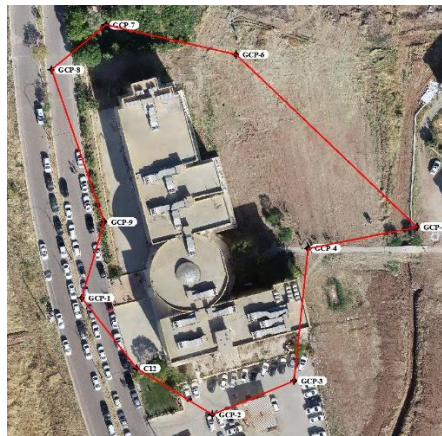
Nine ground control points were constructed around the building. 60*60 cm flex-painted targets were used to designate the points. The coordinates of these points were determined using GPS measurements made with a Leica Viva GNSS, a GS10 base receiver, and a GS15 rover receiver. The system's accuracy at a single base is given as $\pm 8\text{mm} \pm 1 \text{ ppm}$ for the horizontal component and $\pm 15\text{mm} \pm 1 \text{ ppm}$ for the vertical component. The GS10 GNSS receiver was installed on a known control (C12) point in the study region. As illustrated in Figure 2, the GNSS GS15 receiver was employed as a rover station for measuring and recording data on the 9 GCPs dispersed around the building.

Figure 2: Study area overlain measured GCP's

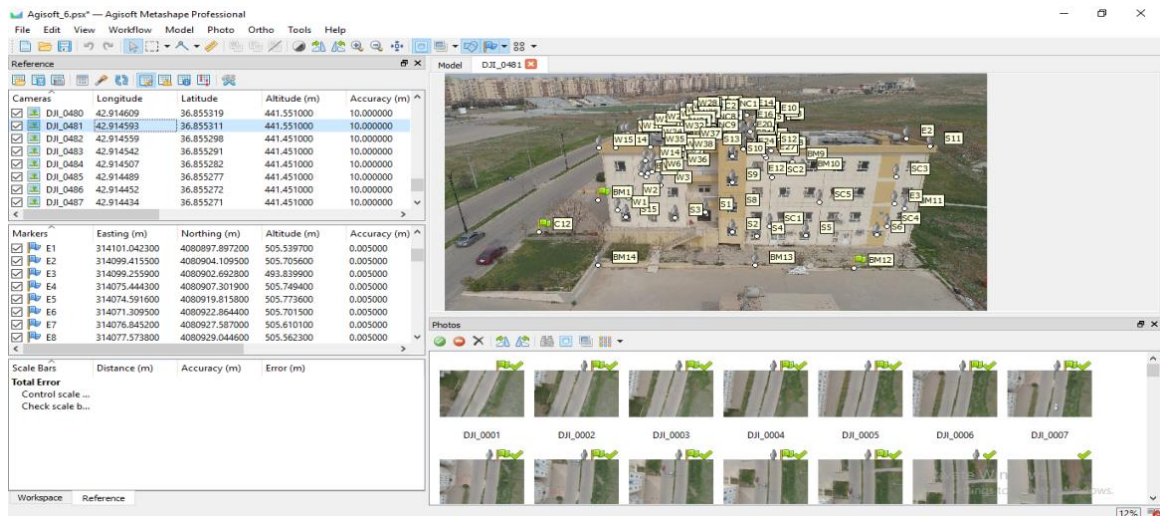
Figure 6 depicts the active window of Agisoft PhotoScan. The window can display the chosen image, the 3D model, the workflow, the image perspective centers, and the details of the GCPs.

Figure 6: Active window of Agisoft PhotoScan software

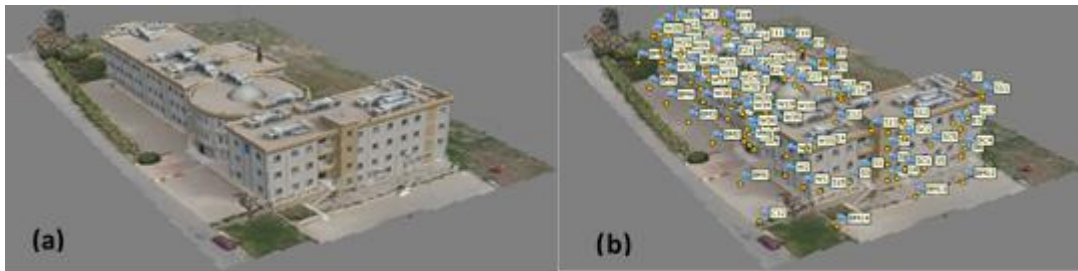
The dense cloud medium-quality process takes around 2 hours. The tiled model is shown in Figure 7a, and the tiled model with a GCPs marker is shown in Figure 7b

Figure 7: a.) The tiled model. b.) The tiled model overlains control points

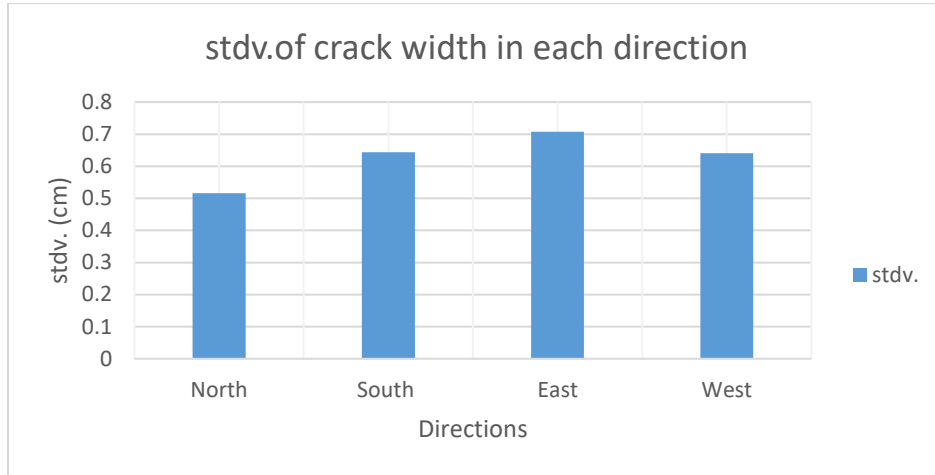
0.72 cm. Also, the standard deviation of the discrepancy between the actual and measured value can be shown in Figure 11.

Figure 11: standard deviation of the discrepancy in building direction

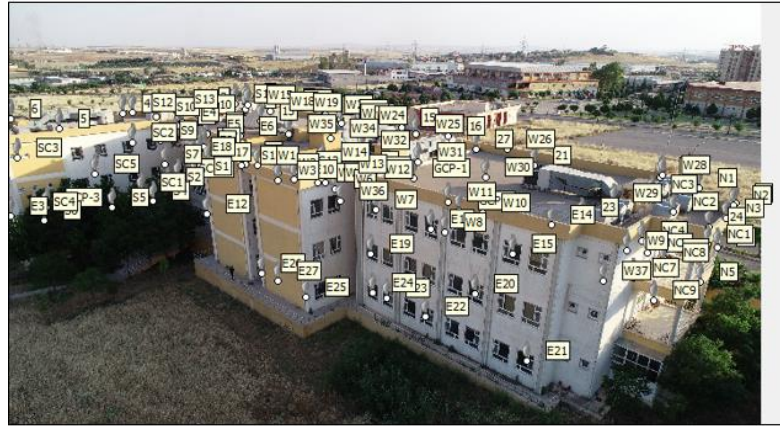
- Buildings with regular shapes necessitate vertical (nadir) and oblique image coverage. Because of the absence of vertical coverage, model deformation is to be expected. When GCPs are added for the Geo-referencing process in AgisoftPhotoscan, the images on which points are chosen show all of the control points on the front and back sides (Kattan et al., 2022). Figure 17 depicts the building of the East façade image under processing and the position of the control points. Besides the east side control points, the west and south facade control points are visible. The study team observed

the exact comment on the building model. This issue could be regarded as a disadvantage in the software design to be tackled, as the model seems transparent, revealing all sides of the control points.

Figure 17: Revealing all sides of the control points: The East side, the West, and South facades
